*Details matter*

With the help of one of our partners, who previously purchased a whole container of river stone washbasins from the “producer” without experience, we managed to prepare documentation using photographs to demonstrate several errors in the production of stone washbasins that make it impossible to connect such washbasins in a bathroom.

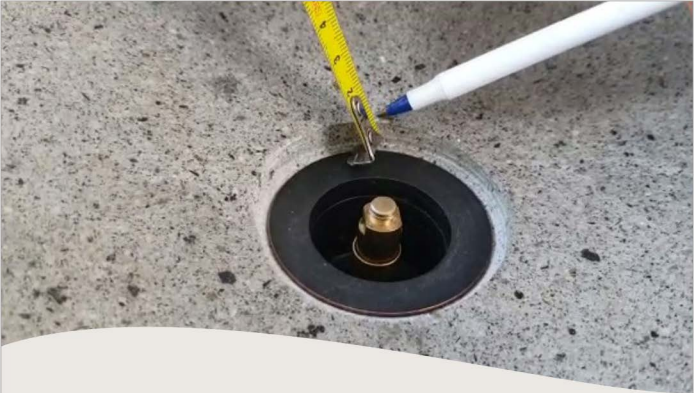
Defect number 1:

***Crooked drain hole***

The drainage holes in the washbasins were drilled crookedly, likely done manually. As a result, the recess for the drain plug is 2 mm on the right side and 8 mm on the left side. The drain plug will not be level, meaning the pipe under the washbasin cannot be connected. Additionally, a push-down/pop-up type plug will not be able to function. This defect alone renders the washbasin unsuitable for use. Furthermore, water will not be able to drain completely, and there will always be some remaining in the lowest point of the drain hole.

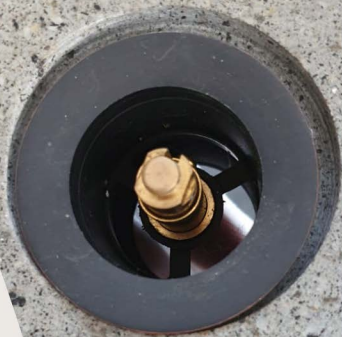
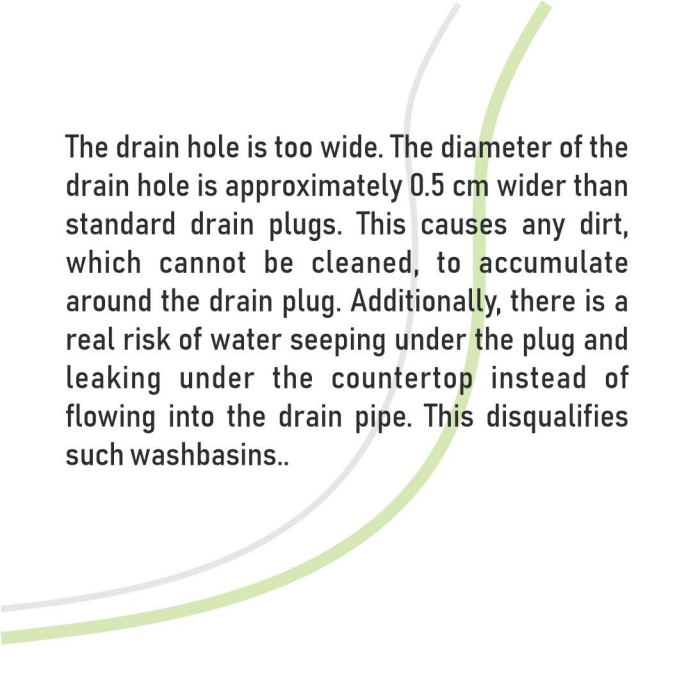
Defect number 2:

*Too wide  
drain hole*

The drain hole is too wide. The diameter of the drain hole is approximately 0.5 cm wider than standard drain plugs. This causes any dirt, which cannot be cleaned, to accumulate around the drain plug. Additionally, there is a real risk of water seeping under the plug and leaking under the countertop instead of flowing into the drain pipe. This disqualifies such washbasins..

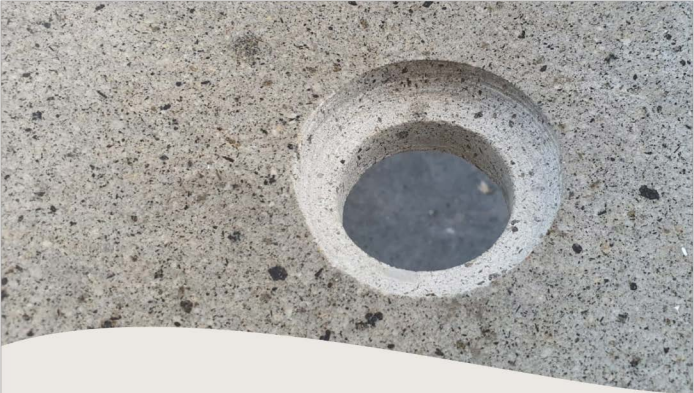
Defect number 3:

***Not polished drain hole***

The drain hole is not polished. This will cause the washbasins to absorb moisture and water in that area, potentially increasing the weight of the washbasin by up to 2 times. While this doesn't completely disqualify the washbasins, it poses a real risk for suspended cabinets on which such washbasins will be placed.
